Dam ID: HI00030

Date: 18 March 2006 (Rev)

**STATE OF HAWAII - DLNR
VISUAL DAM SAFETY INSPECTION SHEET**

Dam/Res. Name	<u>Ka Loko</u>	
Owner	<u></u>	
Owner Contact	<u></u>	Owner Ph. <u></u>
Lessee	<u></u>	Lessee Ph. <u></u>
O & M Contractor	<u></u>	O & M Ph. <u></u>
Nearest City	<u>Kilauea</u>	Latitude <u></u> ° (decimal)
County	<u>Kauai</u>	Longitude <u></u> ° (decimal)
Tax Map Key(s)	<u></u>

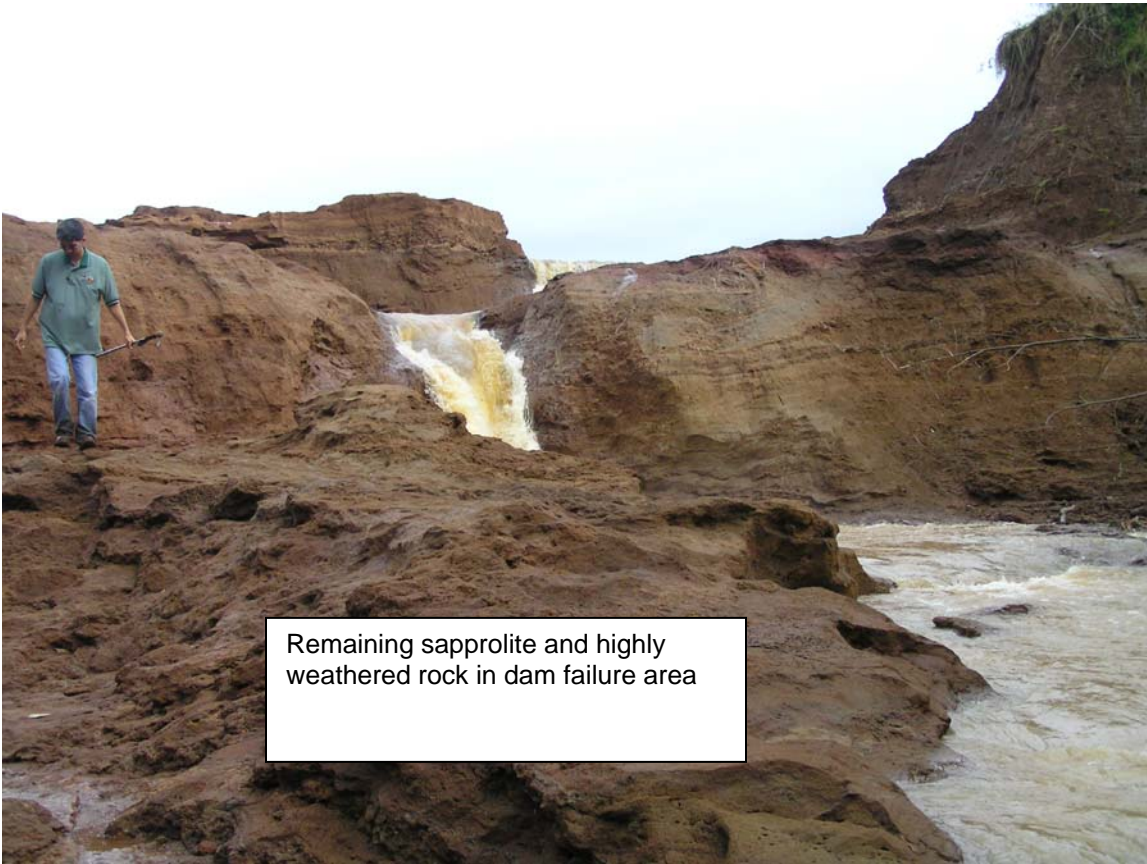
Sapprolite and highly weathered rock observed in failed dam area. This material is erodable; therefore recommend monitoring flow into the area for effects, especially during high rainfall periods. Re-assess at that point.

Looking at dam failure area

Short-term recommendation: Investigation and analysis by geotechnical professional engineer hired by the owner.
